## Measurements between 1<sup>st</sup> and 2<sup>nd</sup> dryer group

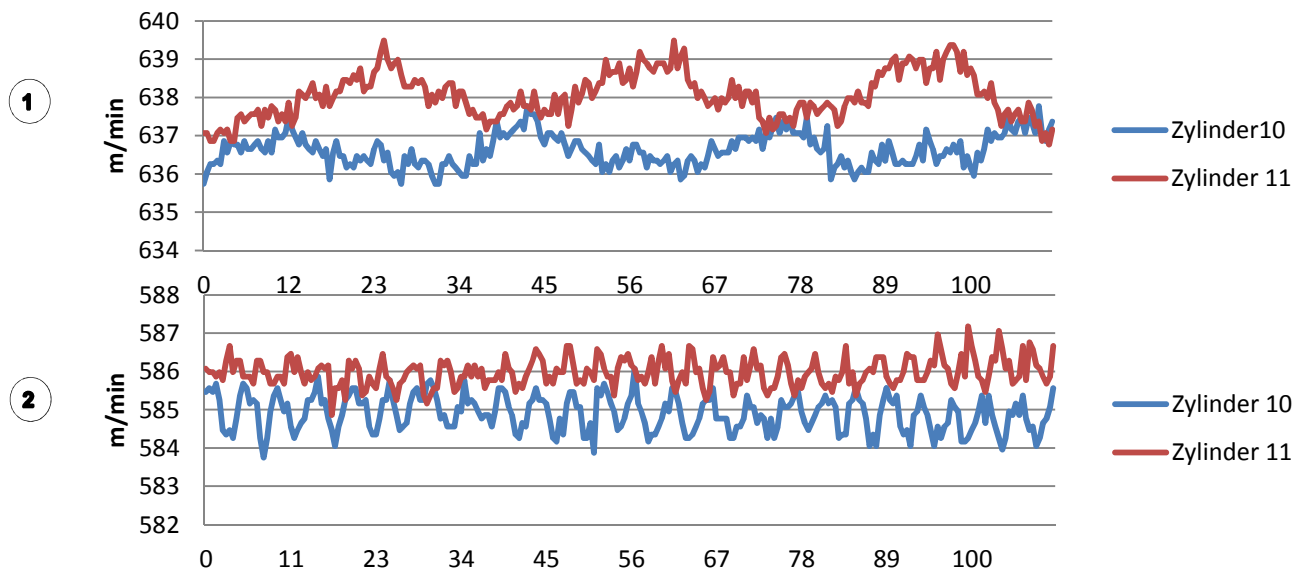
**Problem:** Infrequent sheet breaks without obvious reasons between 1<sup>st</sup> and 2<sup>nd</sup> dryer group. Unfortunately on this PM no sheet inspection system is installed, so no reasons could be found for the additional breaks (approx. 20 more than usual).

**Solution:** Speed measurements between 1<sup>st</sup> and 2<sup>nd</sup> dryer group. In each group a sensor was installed to measure both groups in the same time. The results showed that the speed controllers of both groups worked in reverse to each other - see ①

After repairing the speed controller the defect was fixed and the control parameters came back into normal conditions. The break rate became normal -see ②
