Determination of periodic MD mass variations in the paper sheet

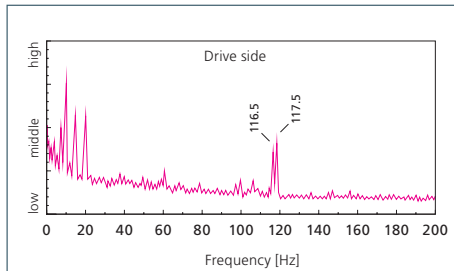
Fig. 5 Variations in the sheet after calender

The first measurement on the drive side after the calender (Fig. 4) showed mass variations in the sheet with the frequencies very close to each other of 116.5 and 117.5 Hz (Fig. 5).

In the vibration diagram (Fig. 6) the same two frequencies are clearly seen, which show the mass variations in the sheet (barring) as variations of 116.5 and 117.5 Hz. The comparison of these values with the rotation frequencies of the calender rolls shows the following result: The mass variation of 116.5 Hz is 12 times (the 12. harmonic) of the rotation frequency of calender roll 3, whilst the mass variation of 117.5 Hz is the 12. harmonic of the rotation frequency of calender roll 2.

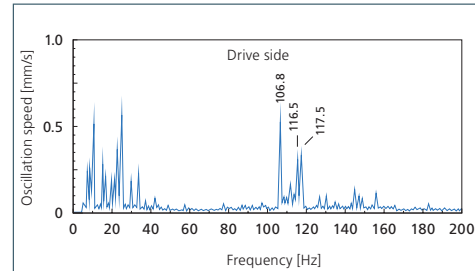
Fig. 6 Vibration measurement on the calender

From this it can be shown that both roll 3 and roll 2 have developed 12 flats. From this situation and from the calender roll circumference a barring with a spacing of approx. 18cm was calculated and confirmed in the sheet. Another interesting aspect: In the vibration measurement (Fig. 6) a peak at 106.8 Hz with a high oscillation velocity can be seen. This is the 11. harmonic of the rotation frequency of roll 3. Although this frequency dominates in the vibration, it does not show up in the sheet.

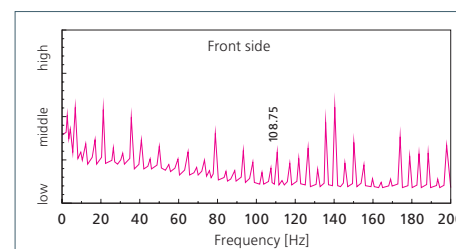
Fig. 8 Variations in the sheet section after the dryer section

On the occasion of a routine measurement of the sheet immediately after the dryer section on the front side (Fig. 7), a number of mass variations were recorded (Fig .8).

The rotation diagram shows 16 peaks being the 16 flats on the surface of the venta roll. However, this disturbance factor is only one of the many peaks in both diagrams (Fig. 8 and 9), namely the one at 108.75 Hz. In this case it was only possible to recommend that the venta roll of the 4. press should be changed.

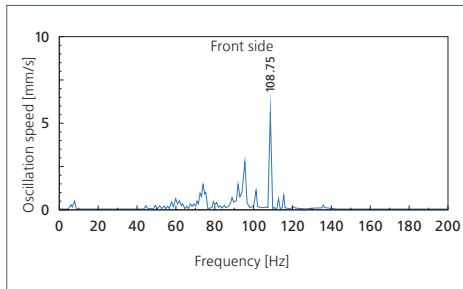
Fig. 9 Total 4. press oscillations, measured on top roll in nip direction

Firstly, the total vibration measurement of the 4. press measured on the top roll in the nip direction (measuring position in Fig. 7, Fig. 9), at 108.75 Hz showed an oscillation velocity of over 6 mm/s. This frequency was found to be the 16. harmonic of the rotation frequency of the venta roll of 6.7968 Hz, as confirmed by the synchronised time signal of this roll (Fig. 10).

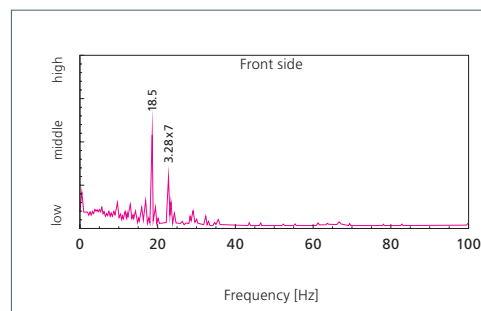
Fig. 12 Variations in the paper sheet after the calender, forming wire shake frequency 3.28 Hz, Stroke 7

The first measurement after the calender (Fig. 11) produced various mass variations in the range of 10-37 Hz including, however, a significant deviation at 18.5 Hz (Fig. 12).

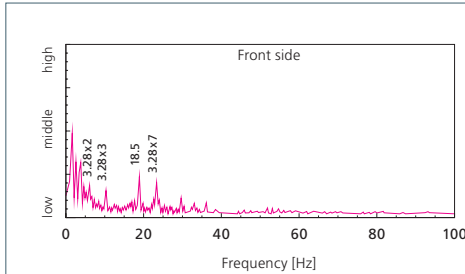
Fig. 13 Variations in the sheet after the twin wire former, Shake frequency 3.28 Hz, Stroke 7

During spot checks on the sheet in the direction of the headbox the same values kept reappearing. This applied also to the frequency pattern recorded on the bottom wire after the top wire former (measuring position in Fig. 11, Fig. 13).

A test carried out by increasing the shake frequency and stroke of the bottom wire and also by disconnecting the shake resulted in the measurements after the twin wire former showed increased deviations from the mean basis weight. Only the peaks at 18.5 Hz remained unchanged.

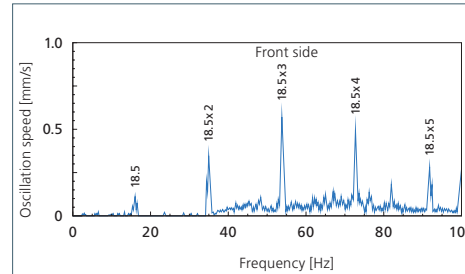
Fig. 14 Total oscillations of stock mixing pump in axial direction

This proved that the shake – irrespective of its frequency – was **not the cause** of the mass variation. Further investigation in the short circulation system all measurements showed up the 18.5 Hz oscillation. Finally, a total vibration analysis in the axial direction on the stock mixing pump, which showed several harmonics of 18.5 Hz (measuring position in Fig. 11, Fig. 14) led to success – in combination with the rotation frequency of this stock pump which was found to be exactly 18.5 Hz.

These findings explain the presence and the constancy of the of the mass variations throughout the whole paper machine. The stock pump created a disturbing impulse in the stock flow once per revolution, which then showed up in the formation as a mass variation in the machine direction. When the stock pump was opened up, it was found to be heavily contaminated particularly on one blade. After the whole pump was thoroughly cleaned the barring at 18.5 Hz was immediately eliminated.

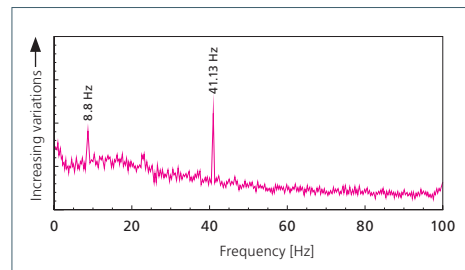
Fig. 16 Variations, measured before reel 855.7 m/min

The first measurement before the reel (Fig. 15) was taken at a fabric speed of 855.7 m/min and showed a dominant peak of mass variations at 41.13 Hz (Fig. 16). All further measurements in the direction of the headbox including the measurement between Vacufoils 1 and 2 showed this mass variation at the same frequency 41.13 Hz (Fig. 17).

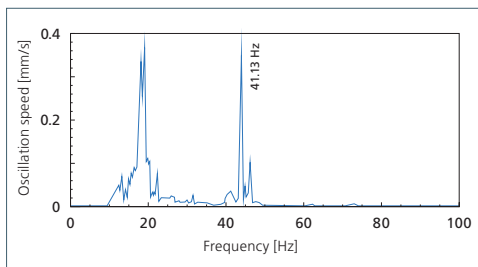
Fig. 18 Oscillations of intermediate pressure screen in radial direction top; wire speed 855.7 m/min

Vibration measurements at the headbox, at the valves of the centrifugal screens and at the screens themselves repeatedly showed a frequency of 41.13 Hz. At the middle pressure screen, however, the highest amplitude in this critical frequency range was measured (Fig. 18).

With a special computer program it is possible to relate disturbing frequencies to a bearing, when the type of bearing and the number of revolutions are known. With this technique it was possible to establish that the rotor bearing of the middle pressure screen was the cause of vibrations in the critical frequency range. Despite the fact that no damage to the rotor bearing was visible, a change was made. After installing the new rotor bearing in the pressure screen the disturbing frequency was no longer present as vibration and as mass variation.

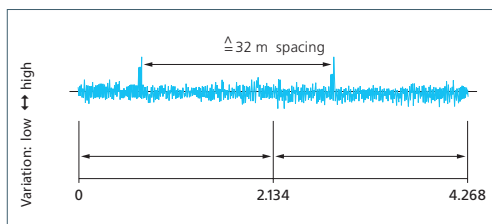
Fig. 20 Trigger signal bottom wire (forming section)

Finally, the recently changed bottom forming fabric, which incidentally was also about 32 m long, was identified as the cause of the disturbance (see trigger position bottom fabric (Fig. 19).

Fig. 20 shows the high peaks causing the disturbance in the sheet from the bottom fabric. For confirmation two revolutions of the fabric were checked (Fig. 20). The peaks occur clearly at a spacing of 32 m (one per revolution).

In this case a faulty bottom fabric was the cause of the marking in the sheet. This demonstrates that the “textile components” on the paper machine – that is both the fabrics and the press felts – can also create periodic mass variations.

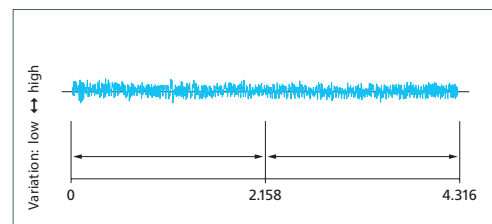
Fig. 21 Trigger signal pick-up felt

In comparison, Fig. 21 shows the synchronised measurement on the pick-up felt. There was no noticeable influence of the pick-up felt on the sheet, although at 32 m long it had originally been thought to be the cause.

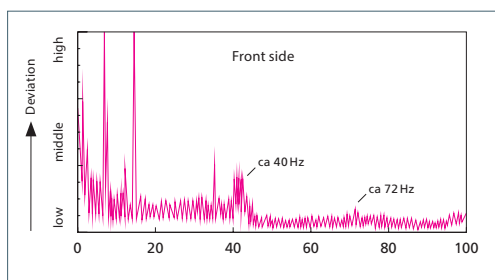
Fig. 22 Mass Variations before reel - Case Study 6

On this LWC machine relatively high MD mass variations were observed before the calender, particularly on the front side. The diagram in Fig. 22 shows a measurement with the ODIN measuring fork on the sheet before the reel-up. The peaks around 20 Hz are not relevant, as was later established; they have other causes, eg. from the calender rolls (thickness variations).

How-ever, the peaks around 40 Hz and 72 Hz, as shown in Fig. 22, are of importance for the mass variations. A relevant measurement on the drive side (Fig. 23) hardly shows any comparable peaks.

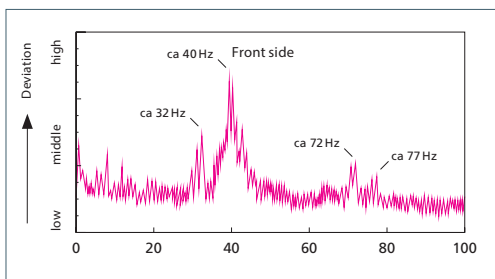
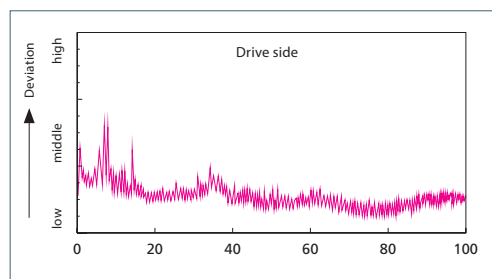
Further measurements were taken in steps from the reel towards the headbox, initially on front and drive side before the calender (Fig.24, 25). Particularly on the front side measurement the peaks at 40 and 72 Hz are more defined than at the reel – and here also the tendency was clear: the variations were significantly greater at the front side than at the drive side.

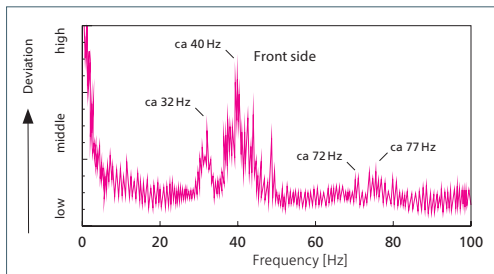
Fig. 26 Mass Variations after 2. Vacufoil section before top wire

The last measurement was on the front side of the forming fabric before the top former and immediately after the 2. Vacufoil section (Fig. 26). Despite the high level of water removal at this point the curve shows a close comparison with the signals from the finished sheet (see Fig. 22 + 24). As a result the suspicion hardened that the cause of the disturbance was not to be found here in the forming section but rather in the approach flow system.

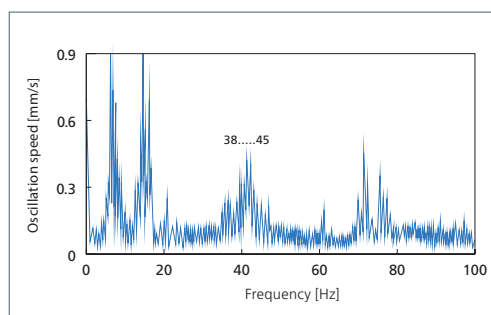
Fig. 28 Vibrations on the backflow line of the headbox

The subsequent measurements on pumps, screens etc. provided no clues; the pattern of the disturbance would also not have been typical for such a source. Also vibration measurements on the backflow line of the headbox just after the control valve (Fig. 27 + 28) did not provide clear agreement.

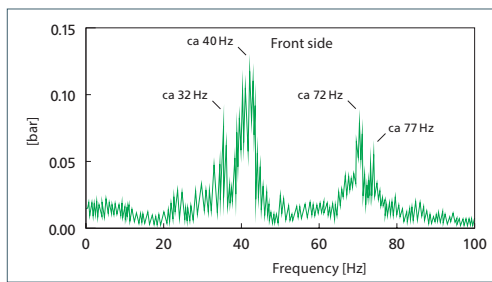
Fig. 29 FFT pressure signal at headbox before change of control valve

The machine measured in this example has pressure sensors installed at front side and drive side of the headbox – and here the breakthrough was made: a frequency analysis (FFT) of the signal of the front side pressure sensor supplied the unambiguous agreement (Fig. 29) with the measurement signals on the finished sheet (see Fig. 24). The stock entry was on the drive side and the stock exit on the front side – where the control valve was positioned.

As a result of this diagnosis Heimbach recommended the replacement of this valve with an improved version. Proof of the validity of this advice is seen in the diagrams in Fig. 30: frequency analysis of the front side pressure sensor, and Fig.31: measurement of the sheet with the ODIN measuring fork on the front side before the calender – both after changing the valve. Also the peaks in the sensor pressure signal and also in the MD mass profile have been eliminated. The measuring and diagnostic effort involved in this case study was very comprehensive, but the efforts were more than rewarded by the discovery of a “confusing” cause.
