To Invest Means to Save Small Issues – Great Effects

'Paper Spikes' and Fabric Wear

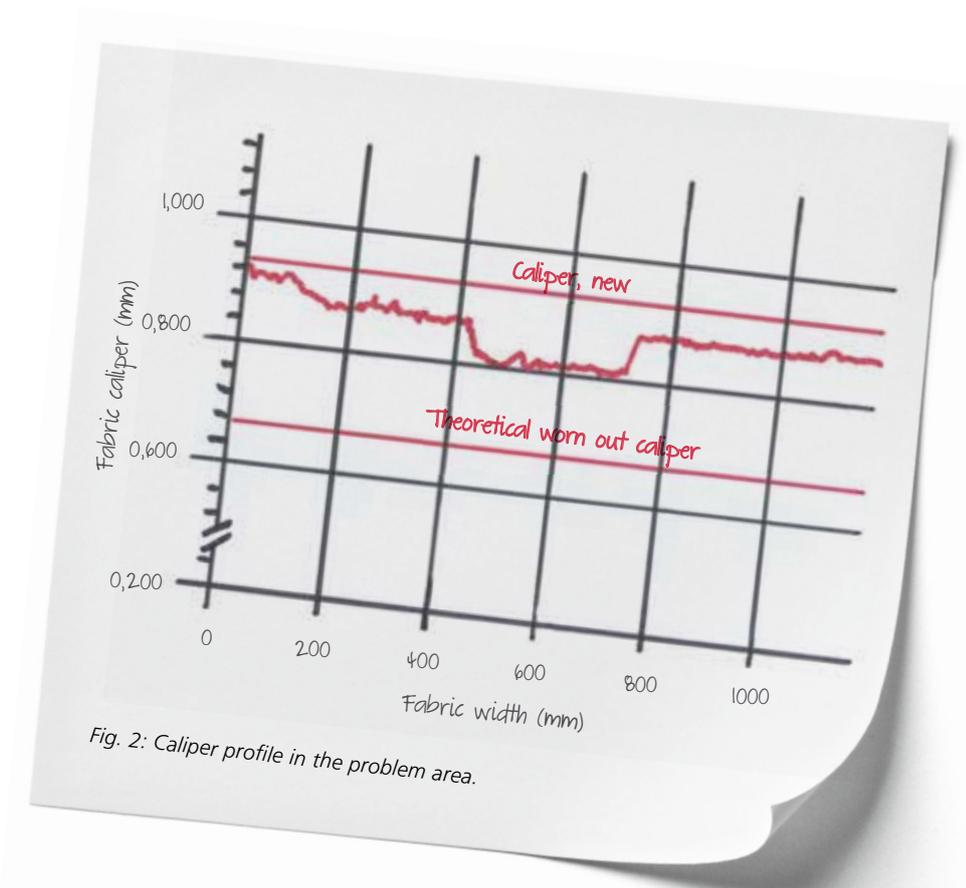
Fig. 2: Caliper profile in the problem area.

bit. Additional comparative caliper measurements confirmed the damaged area (Fig. 2). Therefore the first important discovery was: **The CD profile spikes in the paper resulted from obvious fabric damage.** Now the question to be tackled was what exactly was causing this damage to the clothing.

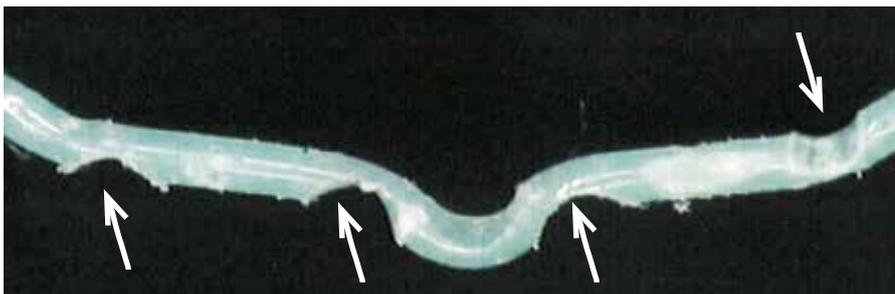
Fig. 1: Very clear: damaged warp.

As is so often the case, we consulted our colleagues at the lab in order to find the reason for the problem. This step always complements our TASK work very well, as the engineers in the laboratory are always able to come up with interesting facts. This additional insight enriches our TASK analyses of the paper machines and **provides the customer with clarity** – both quickly and effectively – in terms of the problem. In the aforementioned case we were able to determine “internal” damage resulting from extreme internal abrasion on warp and weft (Fig. 1). We knew immediately: Very high force must have been applied to the fabric, so that it was being “compressed” bit by

again with the machine both stopped and when running in order to determine the cause of the damage. Intensive inspections followed on site and when we discovered the solution to the puzzle we were very surprised because it was indeed a very small cause that was responsible for the enormous effect, i.e.: **One single nozzle of the HD cleaning shower was damaged!**

The aforementioned nozzle generated an extremely turbulent water jet, which in turn caused strong pulsation. The water jet hitting the fabric had a “hammer” effect, and as a result the fabric was being “beaten up”: In addition to the “wrecking” mentioned earlier the fabrics within the problem area were obviously hardly cleaned at all, which meant an additional loss of efficiency. **The customer’s maintenance staff fixed the HD shower on advice of our TASK department** as there were many other nozzles that were not in optimal condition. When the shower was restored to optimal condition, with all nozzles working properly again, **forming fabric lifetimes were**

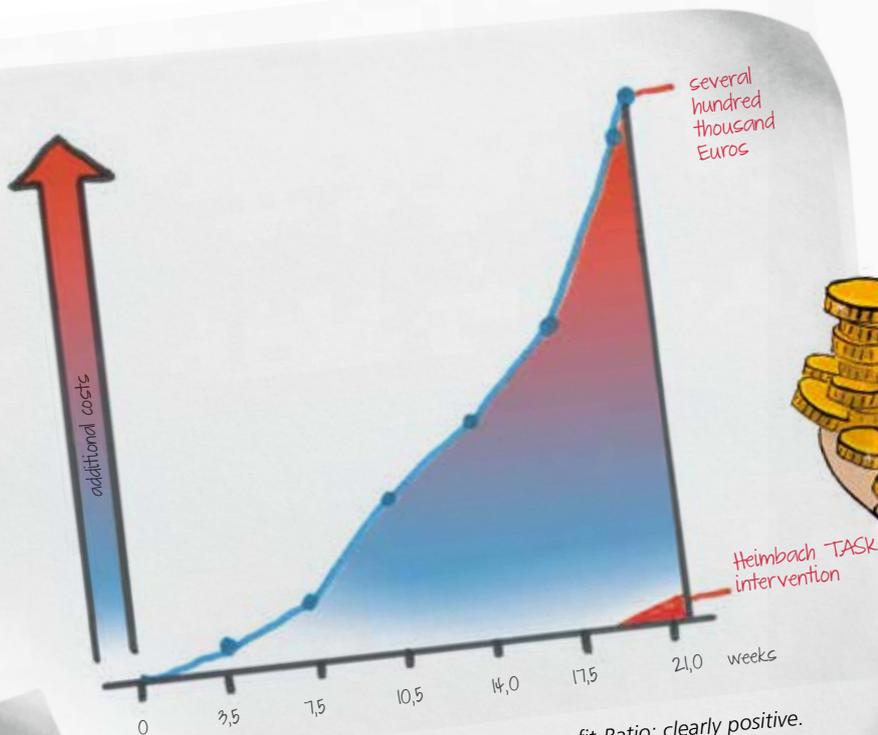
Fig. 3: Cost-Benefit-Ratio: clearly positive.

several hundred thousand Euros! As figure 3 shows graphically, clothing costs had increased dramatically. Furthermore unnecessary downtime was costing time and money as well as loss of production – let alone rejects and complaints from printers. All this is now in the past – and this is thanks to an investment that is hardly worth mentioning when compared to the result: **Our customer had to pay less than 3,000 Euros for materials and repair!**
