Continuous conditioning of forming fabrics with high pressure showers

General observations on the technical process – and a case study of a problem – and its solution

Chris Kershaw, Vice President Corporate Marketing, Heimbach UK Ltd., chris.kershaw@heimbach.com
Hans J. Struck, PMS GmbH, Offenburg, pms-struck@rubynozzle.com

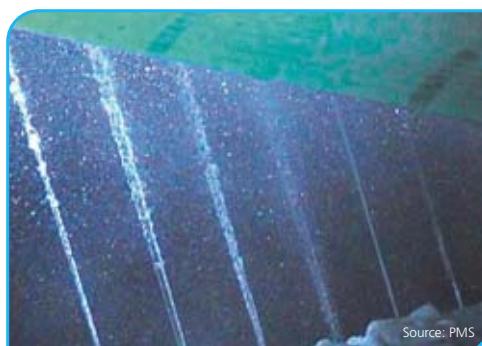
Fig.7 Various types of water jets

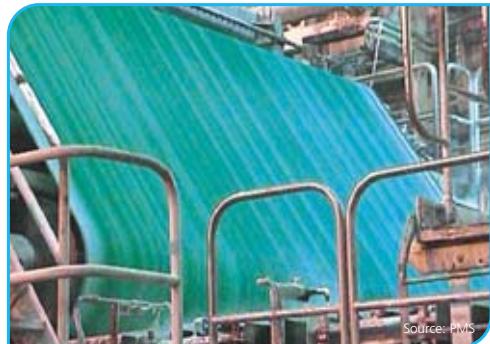
Fig.8 Uneven coverage

Modern Ruby nozzles, with their high jet quality and long life performance, will usually eliminate most of the problems described above. A regular check-up of the water jets is recommended in order to identify and rectify any problems at an early stage. Defective, contaminated or partly blocked nozzles will lead to a change in the water jet properties (Fig.7), causing uneven coverage across the fabric width (Fig.8) and poor cross direction profiles in the sheet.

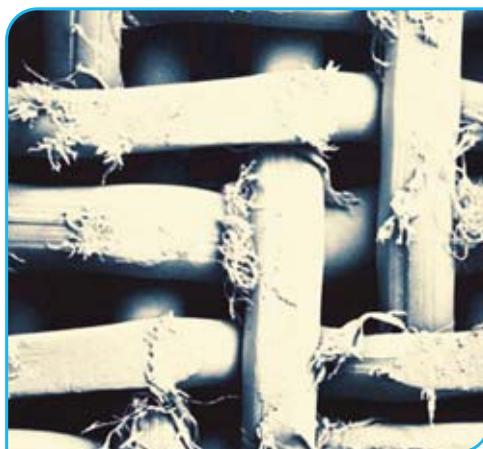
Fig.10 Fabric damage through excessive jet impact

As a general rule the pressure should be as high as necessary in order to achieve good cleaning results, and it should be kept as low as possible in order to avoid damage to the fabric (Fig.10), and in the interest of energy efficiency.

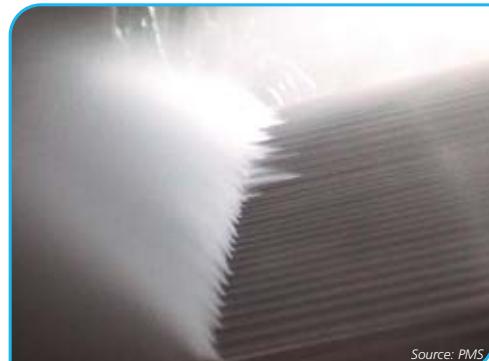
Fig.12 Water mist in the space inside the fabric return loop

This water is diffused by the fabric structure and movement and can create a water mist on the inside of the return loop (Fig.12).

The high concentration of contaminant material in this mist can cause problems with deposit build up in the forming section especially on high-speed machines. Suction boxes are often installed to take up and remove this water mist.
