Determination of periodic MD mass variations in the paper sheet

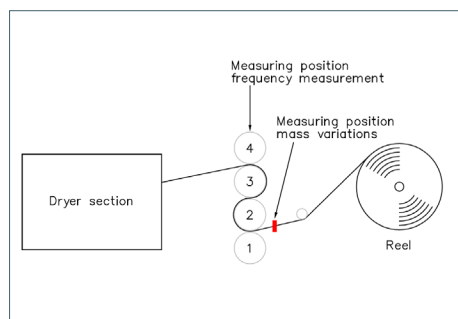
Fig. 4 Measuring Positions Case Study 1

The first measurement on the drive side after the calender (Fig. 4) showed mass variations in the sheet with the frequencies very close to each other of 116.5 and 117.5 Hz (Fig. 5).

Vibration measurement on the calender:

Roll 4	8,4289 Hz
Roll 3	9,7080 Hz
Roll 2	9,7920 Hz
Roll 1	7,5060 Hz

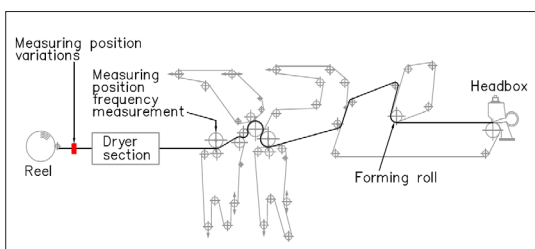
Fig. 7 Measuring Positions Case Study 2

On the occasion of a routine measurement of the sheet immediately after the dryer section on the front side (Fig. 7), a number of mass variations were recorded (Fig .8).

Firstly, the total vibration measurement of the 4. press measured on the top roll in the nip direction (measuring position in Fig. 7, Fig. 9), at 108.75 Hz showed an oscillation velocity of over 6 mm/s. This frequency was found to be the 16. harmonic of the rotation frequency of the venta roll of 6.7968 Hz, as confirmed by the synchronised time signal of this roll (Fig. 10).

The rotation diagram shows 16 peaks being the 16 flats on the surface of the venta roll. However, this disturbance factor is only one of the many peaks in both diagrams (Fig. 8 and 9), namely the one at 108.75 Hz. In this case it was only possible to recommend that the venta roll of the 4. press should be changed.

The forming roll of the twin wire former (Fig. 7) provided with its basic frequency (rotation frequency) of 4.82 Hz the starting point for all frequency values which were a multiple (an x. harmonic) of this basic frequency.

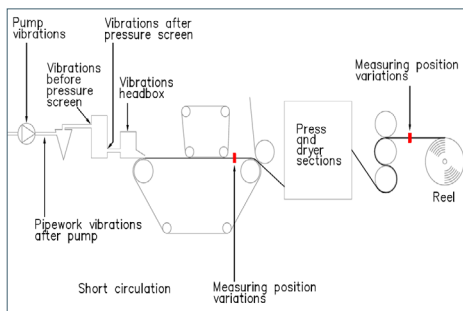
Fig. 11 Measuring Positions Case Study 3

The first measurement after the calender (Fig. 11) produced various mass variations in the range of 10-37 Hz including, however, a significant deviation at 18.5 Hz (Fig. 12).

During spot checks on the sheet in the direction of the headbox the same values kept reappearing. This applied also to the frequency pattern recorded on the bottom wire after the top wire former (measuring position in Fig. 11, Fig. 13).

This proved that the shake – irrespective of its frequency – was **not the cause** of the mass variation. Further investigation in the short circulation system all measurements showed up the 18.5 Hz oscillation. Finally, a total vibration analysis in the axial direction on the stock mixing pump, which showed several harmonics of 18.5 Hz (measuring position in Fig. 11, Fig. 14) led to success – in combination with the rotation frequency of this stock pump which was found to be exactly 18.5 Hz.

These findings explain the presence and the constancy of the of the mass variations throughout the whole paper machine. The stock pump created a disturbing impulse in the stock flow once per revolution, which then showed up in the formation as a mass variation in the machine direction. When the stock pump was opened up, it was found to be heavily contaminated particularly on one blade. After the whole pump was thoroughly cleaned the barring at 18.5 Hz was immediately eliminated.

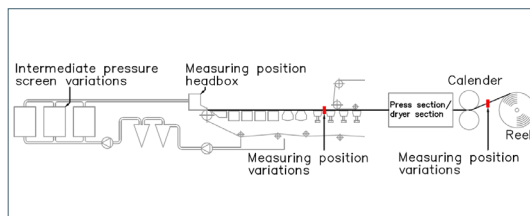
Fig. 15 Measuring Positions Case Study 4

The first measurement before the reel (Fig. 15) was taken at a fabric speed of 855.7 m/min and showed a dominant peak of mass variations at 41.13 Hz (Fig. 16). All further measurements in the direction of the headbox including the measurement between Vacufoils 1 and 2 showed this mass variation at the same frequency 41.13 Hz (Fig. 17).

Vibration measurements at the headbox, at the valves of the centrifugal screens and at the screens themselves repeatedly showed a frequency of 41.13 Hz. At the middle pressure screen, however, the highest amplitude in this critical frequency range was measured (Fig. 18).

With a special computer program it is possible to relate disturbing frequencies to a bearing, when the type of bearing and the number of revolutions are known. With this technique it was possible to establish that the rotor bearing of the middle pressure screen was the cause of vibrations in the critical frequency range. Despite the fact that no damage to the rotor bearing was visible, a change was made. After installing the new rotor bearing in the pressure screen the disturbing frequency was no longer present as vibration and as mass variation.

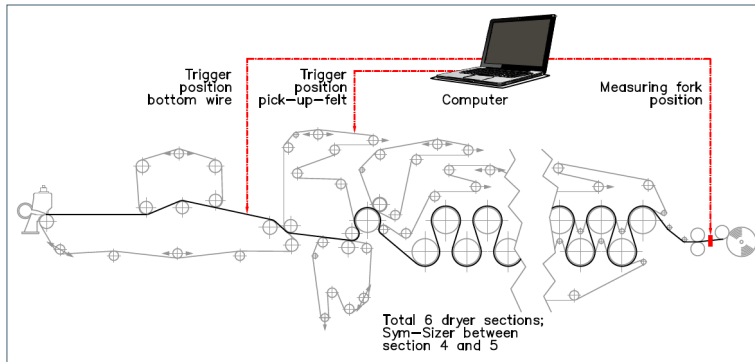
Fig. 19 Measuring Positions in the Paper Machine Case Study 5

The ODIN measuring fork was installed on the drive side of the machine before the reel (Fig. 19). As the disturbance was at a frequency well below 1 Hz and in addition, regularly, but only very briefly peaked, a frequency analysis would have provided no information. Therefore time signals were examined.

In order to localise the cause, the revolution or rotation signal of a “suspicious” forming fabric, press felt or dryer fabric was established and the measurement from the sheet synchronised with it. Measurements were then made step by step moving from the reel towards the headbox in order to find the position where the frequency pattern **no longer** tied in with the disturbance (mass variation). The cause must be found between this point and the last point where the frequency pattern showed the disturbance.

Finally, the recently changed bottom forming fabric, which incidentally was also about 32 m long, was identified as the cause of the disturbance (see trigger position bottom fabric (Fig. 19).

In this case a faulty bottom fabric was the cause of the marking in the sheet. This demonstrates that the “textile components” on the paper machine – that is both the fabrics and the press felts – can also create periodic mass variations.

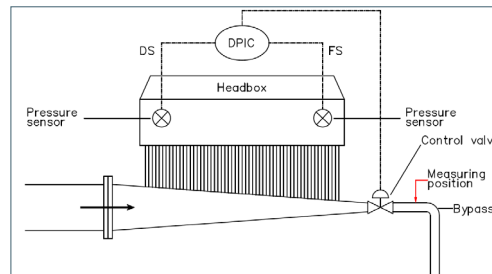
Fig 27 Schematic Layout of pressure sensors and backflow line of the headbox

The subsequent measurements on pumps, screens etc. provided no clues; the pattern of the disturbance would also not have been typical for such a source. Also vibration measurements on the backflow line of the headbox just after the control valve (Fig. 27 + 28) did not provide clear agreement.
